Topic: Insufficient Fire Flow in along Balcones Dr.

## **AUSTIN FIRE DEPARTMENT - FIRE PREVENTION DIVISION**

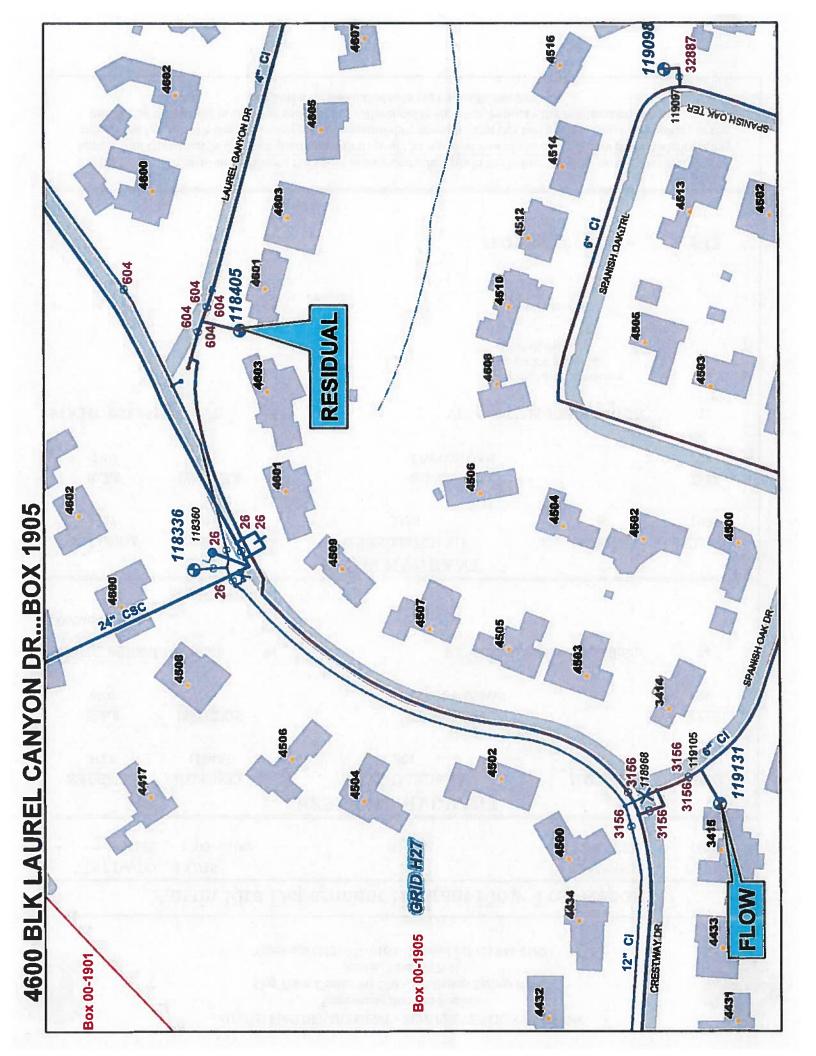
TEST DATE:	4/17/15			COMPANY:	PREV
TIME:	1700 HRS		SHIFT:	OFFICER:	N/N
		RESI	IDUAL HYDRANT		
MAP GRID#	HYDRANT#		PIPE INTERSECTION #	MAIN SIZE	AFD BOX #
H27	118405		604	6	1905
BLK#	DIRECTION		STREET NAME		ТҮРЕ
4600			LAUREL CANYON		DR
STATIC PRESSU	RE (PSI):	94	RESIDUAL	PRESSURE (PSI):	24
COMMENTS:	, , , , , , , , , , , , , , , , , , ,				
	THE PLANT				
		FI	OW HVDD ANT		
			LOW HYDRANT		
MAP GRID#	HYDRANT#		PIPE INTERSECTION #	MAIN SIZE	
MAP GRID # H27	HYDRANT # 119131			MAIN SIZE 6	AFD BOX #
A STATE OF THE PARTY OF THE PAR			PIPE INTERSECTION #		
H27	119131		PIPE INTERSECTION # 3156		1905
H27	119131  DIRECTION	90	3156 STREET NAME SPANISH OAK		1905 TYPE
H27 <u>BLK#</u> 3400	119131  DIRECTION		3156 STREET NAME SPANISH OAK VELOCITY	PRESSURE (PSI):	1905 <u>TYPE</u> DR
H27 <u>BLK#</u> 3400	119131  DIRECTION		3156  STREET NAME SPANISH OAK  VELOCITY  dc = 6 straig	6	1905 TYPE DR
H27 <u>BLK#</u> 3400	119131  DIRECTION		3156  STREET NAME SPANISH OAK  VELOCITY  dc = 6 straig w/45	PRESSURE (PSI):  discharge coefficient  at 2½" butt = .9  elbow = .75	TYPE DR

H27 <u>BLK#</u> 3400	119131  DIRECTION		3156  STREET NAME SPANISH OAK  VELOCITY  dc = 6 straig w/45	PRESSURE (PSI):  discharge coefficient nt 2%" butt = .9	1905 <u>TYPE</u> DR
H27 <u>BLK#</u> 3400	119131  DIRECTION		3156  STREET NAME SPANISH OAK  VELOCITY  dc = 6 straig w/45	PRESSURE (PSI):  discharge coefficient  at 2½" butt = .9  elbow = .75	1905 <u>TYPE</u> DR 15

It has come to my attention that the fire flow in the neighborhood surrounding Balcones Dr from 35th street to Perry Lane is not sufficient to meet the minimum requirement of 1000 gpm at 20psi as required for single family homes by the IFC2012 Appendix B. I would like a representative of WW&W and AFD to address this issue and provide the board with recommendation on how to correct this issue. I will forward a water flow test that I received for a property at 4600 Laurel Canyon. There is a similar poor report for a property at 3420 Mount Barker but I don't have a copy of that report.
